CHART INC.

Case No. 3:20-cv-04988

**COMPLAINT AND  
DEMAND FOR JURY TRIAL**

#### I. Tank 4: A Chart MVE Cryopreservation Tank

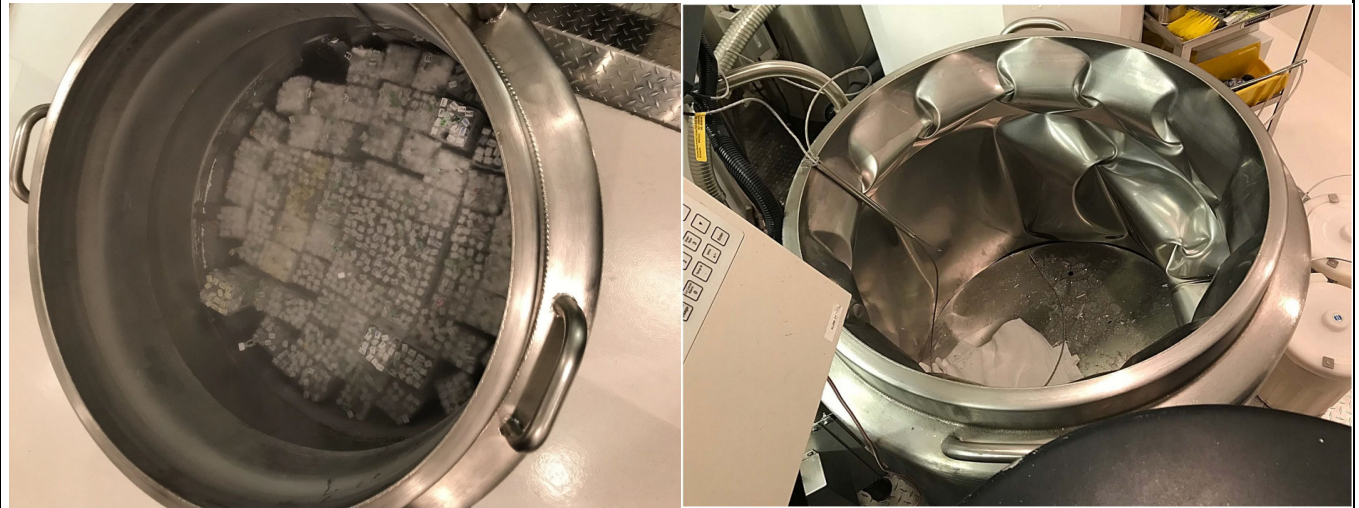
5. The cracked weld also triggered an implosion of the tank's inner vessel, as the liquid nitrogen that was sucked into the vacuum space transitioned to gaseous nitrogen and exerted pressure

on the inner vessel's walls. That is why the lid of the tank was difficult for PFC's embryologists to remove. The imploded tank is shown below, on the right:

*Normal Tank*

*Imploded Tank*

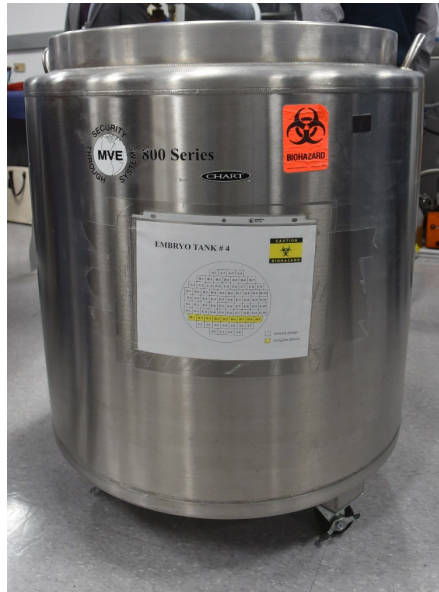
*Tank 4*

1           15.     The tank at issue in this litigation is an MVE-branded cryopreservation tank—  
2 specifically, a model MVE 808AF-GB Stainless Steel Freezer, which the embryologists at the Pacific  
3 Fertility Center referred to as Tank 4:

15           16.     The tank consists of the outer vessel seen above, an inner vessel that can be used to store  
16 eggs and embryos in liquid nitrogen, and an insulated vacuum layer that separates the two vessels and  
17 prevents heat transfer from the surrounding environment.

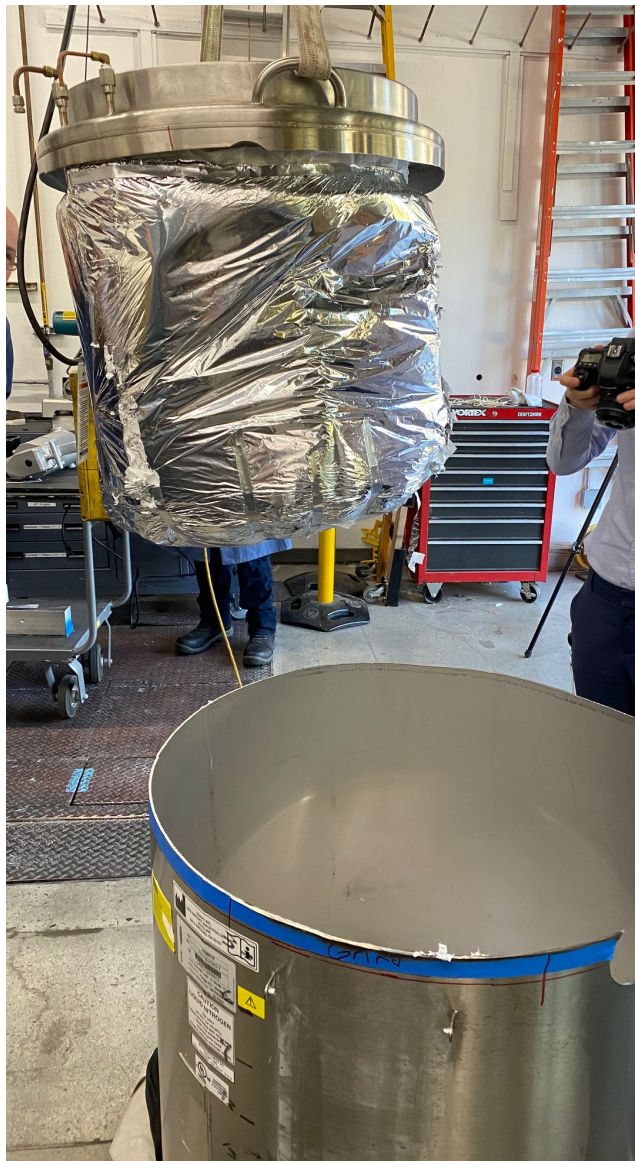
19. The picture below was taken following failure of Tank 4 and shows the tank's inner vessel (wrapped in reflective material) being removed from the outer vessel. In between the two vessels was an interstitial space. Before a tank is put into service, Chart draws a vacuum within that space by sealing it shut and pumping out the air. The resulting vacuum space is what allows cryopreservation tanks to keep liquid nitrogen and biological samples at  $-198^{\circ}\text{C}$ .

*Tank 4's inner vessel suspended after removal from outer vessel (vacuum space was in between)*

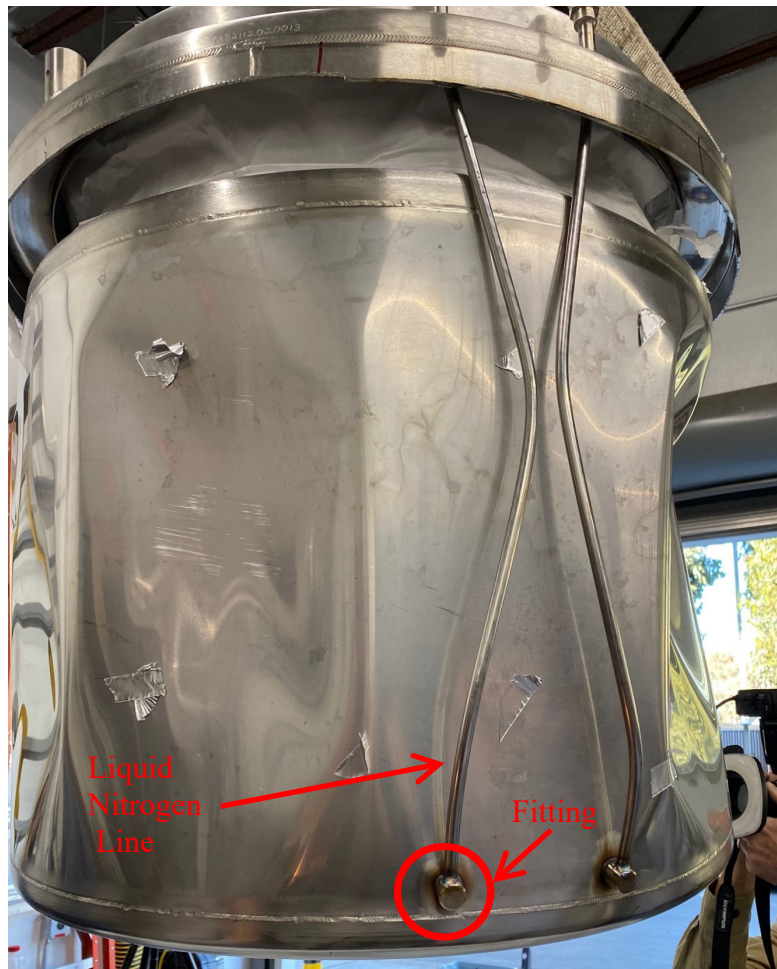
24. Tank 4 was manufactured with a metal tube that is used to refill the tank with liquid nitrogen. The tube ran from the top of the tank, down through the vacuum space between the inner and outer vessel, and then into the inner vessel near the bottom of the tank.

25. The picture below was taken after the outer vessel of Tank 4 was removed. The liquid nitrogen tube is on the left and the red circle shows where it connects to the inner vessel through a fitting.

*Liquid nitrogen tube feeds into Tank 4's inner vessel*

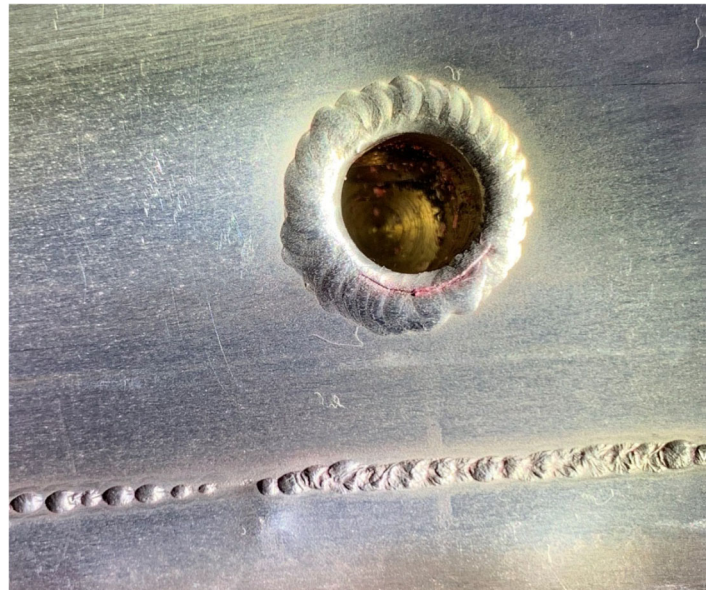
27. The image on the right is the same weld, this time after using Magnaflux Spotcheck liquid dye penetrant. The fact the red dye penetrant remained after the surface was wiped clean is indicative of a crack.

*Red dye indicates a crack in the weld*

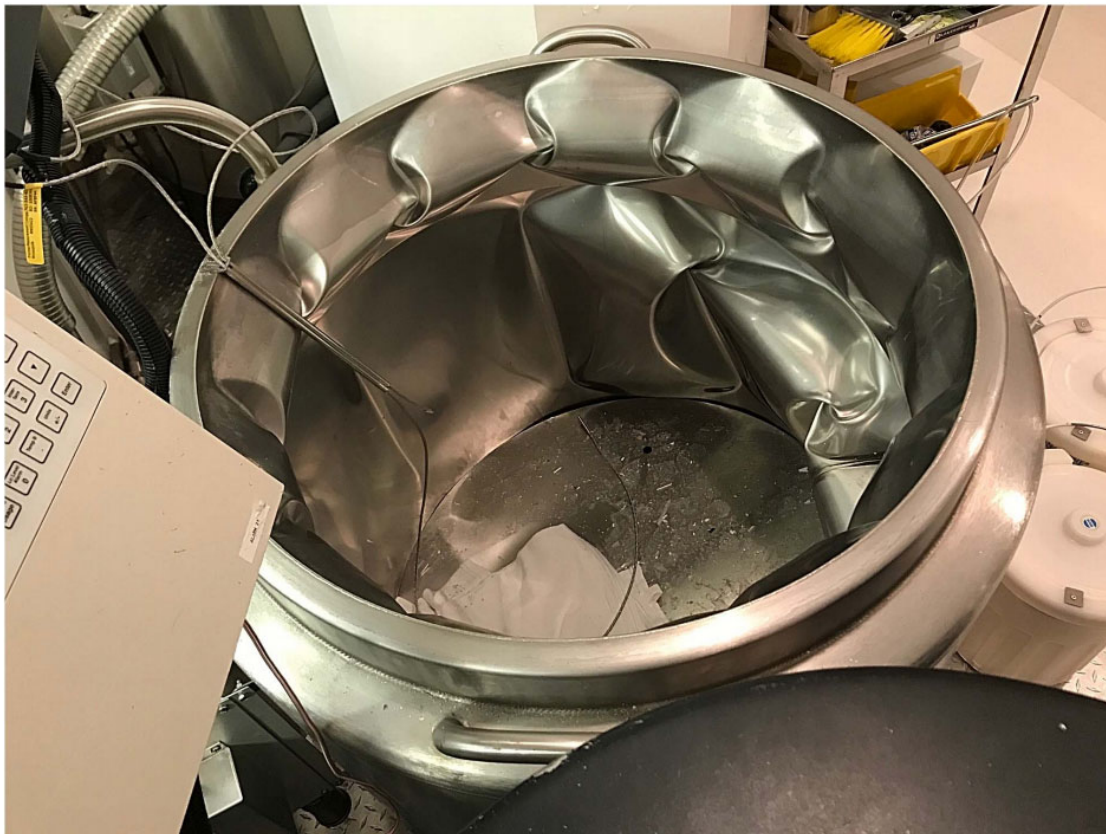
33. The crack and accompanying leak of liquid nitrogen into the interstitial space both destroyed the vacuum insulation that allowed the inner vessel to stay cold and exerted significant pressure on the space between the tank's inner and outer vessel. The inner vessel gave way and crumpled. The following image was taken approximately 36 hours after the PFC embryologists discovered the Tank 4 failure and moved the affected eggs and embryos to another tank.

*Tank 4 after the incident*

34. This dramatically imploded tank is yet another indication of a cracked failure. As part of its compliance with the European Union's Medical Device Directive, Chart was required to attempt to identify every way that its cryogenic freezers could theoretically fail. Representatives from Chart's various departments came up with over a hundred potential failure modes. One of them was a cracked weld at the liquid nitrogen fill tube—exactly what expert analysis revealed happened to PFC's Tank 4. If that weld did crack, Chart wrote that the result would be: "Liquid draws into vacuum space, expanding rapidly and causing an inner vessel implosion, total vacuum loss. Loss of function of the freezer."
